THE CATALYST

SLIPPERY ROCK WATERSHED COALITION MONTHLY ACTIVITIES UPDATE

De Sale Phase 1 Undergoes Successful O&M

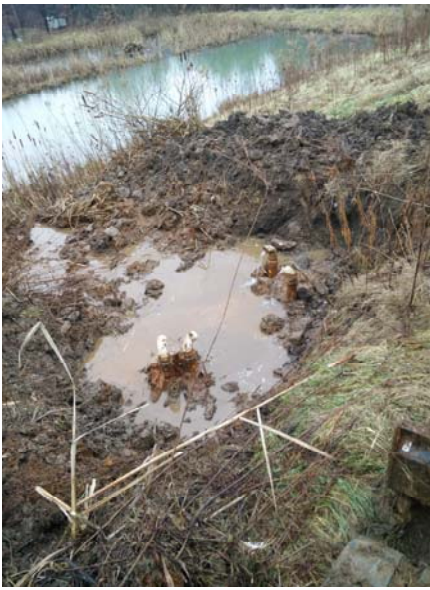
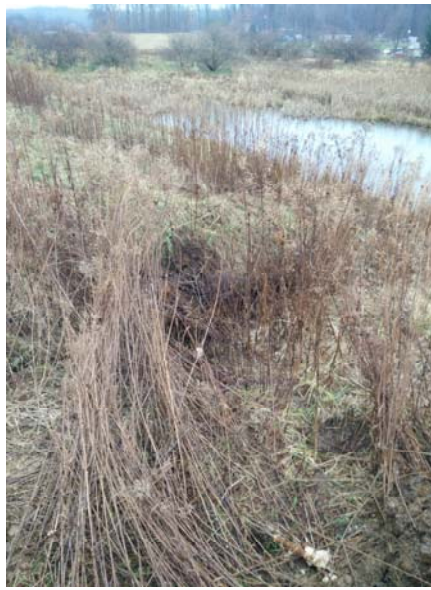
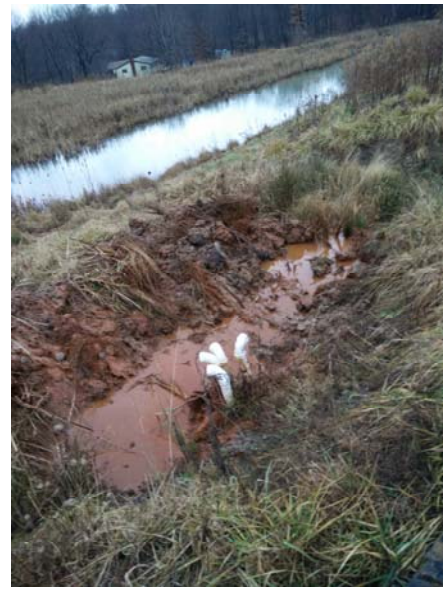
“Before Pictures” showing needed maintenance in May 2013 at the De Sale Phase 1 passive treatment system after 13 years of operation. See article below describing maintenance efforts performed in June 2013.

Thanks to **landowner support**, funding for technical assistance and maintenance from the **PA DEP’s Growing Greener, Stream Restoration Incorporated, Foundation for Pennsylvania Watersheds**, and in-kind volunteer services from the **SRWC, BioMost, Inc.** was able to perform maintenance and upgrades on the De Sale 1 Passive Treatment System in June of 2013. A routine inspection of the system in May 2013 revealed several issues requiring attention for the system installed in 2000. A portion of the flow entering the Vertical Flow Pond (**VFP**) South was overflowing through the emergency spillway into the settling pond. Part of the reason was that the pipe, which directs flow from the Forebay into the VFP North, had become plugged with low-pH iron so that all the water had to go through the VFP South. As the design for “peri-pipes” had not been developed when the VFP South was constructed, standard outlet pipes had been installed, which could not be lowered to increase head pressure. Several pipes were clogged with iron solids and vegetation. Despite the issues, the **13-year old system was still treating the 36-gpm (avg.) mine drainage!!!** The final effluent had a pH of 6.3, 40 mg/L alkalinity, total iron and aluminum of 2 and 0 mg/L, respectively. The raw water averages a pH of 3.6, 320 mg/L acidity, and total iron and aluminum of 82 and 12 mg/L, respectively.

The old outlet structures were removed in the summer of 2013 and replaced with “peri-pipes”. This new upgrade also allows for easier flow measurements and sampling of the system. The channels below the VFP outlets were also restructured and cleared of vegetation, another important maintenance task.

Previous O&M upgrades included stirring the top one to two feet of the VFP North in November 2012 to address permeability issues that were developing, possibly as a result of the accumulation of low-pH iron on top of the compost layer. An earthen ramp was installed at the northeast corner of the VFP North to provide an access point for the skid loader to enter the pond to stir the media.

Water monitoring conducted on September 25, 2014 indicated the system was working well. The final effluent had a 6.4 pH with 70 mg/L of alkalinity. While equipment and tools were at nearby De Sale 2 (*Catalyst* article coming soon!!) to perform maintenance, a site visit was conducted to replace the forebay pipes that periodically plug with low-pH iron at De Sale 1. A 10” pipe was installed in place of each 6” pipe. The pipes installed were also shorter than the previously installed pipes to hopefully reduce frequency of cleaning and to increase the ease of cleaning.
