THE CATALYST

SLIPPERY ROCK WATERSHED COALITION MONTHLY ACTIVITIES UPDATE

Ferris Treatment Complex Receives Maintenance

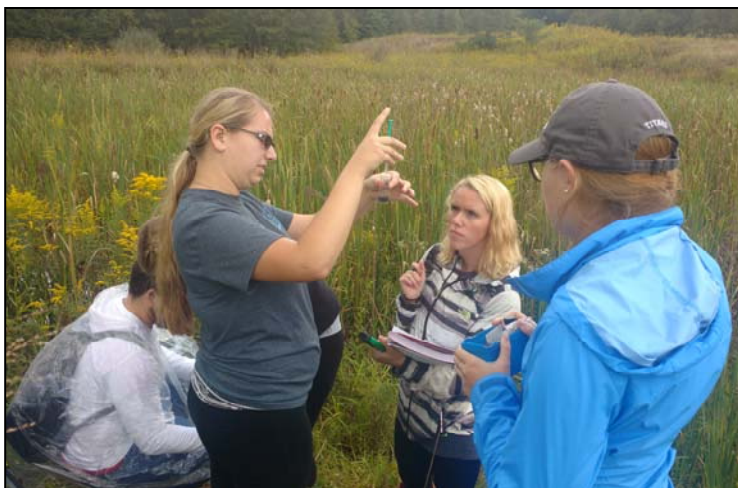
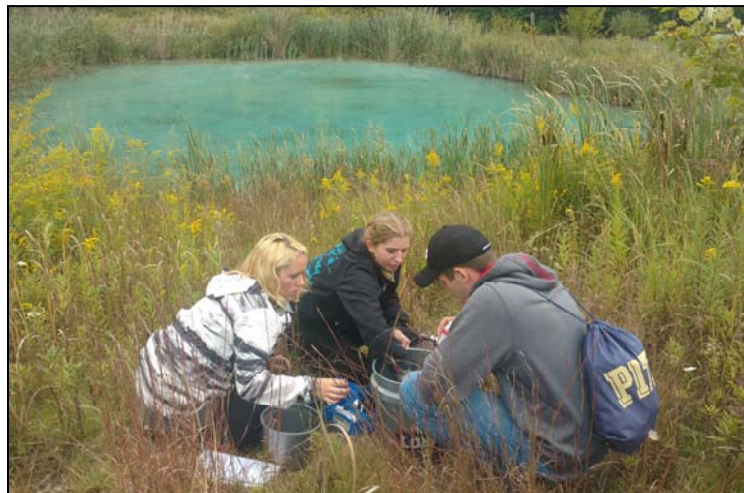
On September 8th, Westminster College students from Dr. Helen Boylan's Advanced Chemistry class visited De Sale Phase 2 as part of their on-going service learning project. It is hard to believe that this was the 11th year of water monitoring by this project. SRWC participants Cliff Denholm of Stream Restoration Incorporated and Wil Taylor of Jennings Environmental Education Center were on hand to provide a tour and lend assistance. Wil and Cliff discussed the watershed, mining history of the site, AMD, and passive treatment. After the tour was completed, the students collected water samples and conducted field water monitoring testing. The students took the water samples back to the lab where they performed a variety of analytical techniques measuring water quality parameters such as pH, alkalinity, acidity, and metals. The students will be presenting their data at the October 12th meeting. This is one of our favorite meetings of the year and we always look forward to listening to and interacting with the students. These college students are a valued asset to the SRWC, helping us collect important information on water quality. Please come out to our October meeting to show them your support for their hard work and learn what they have been discovering about passive treatment's effectiveness at De Sale 2!

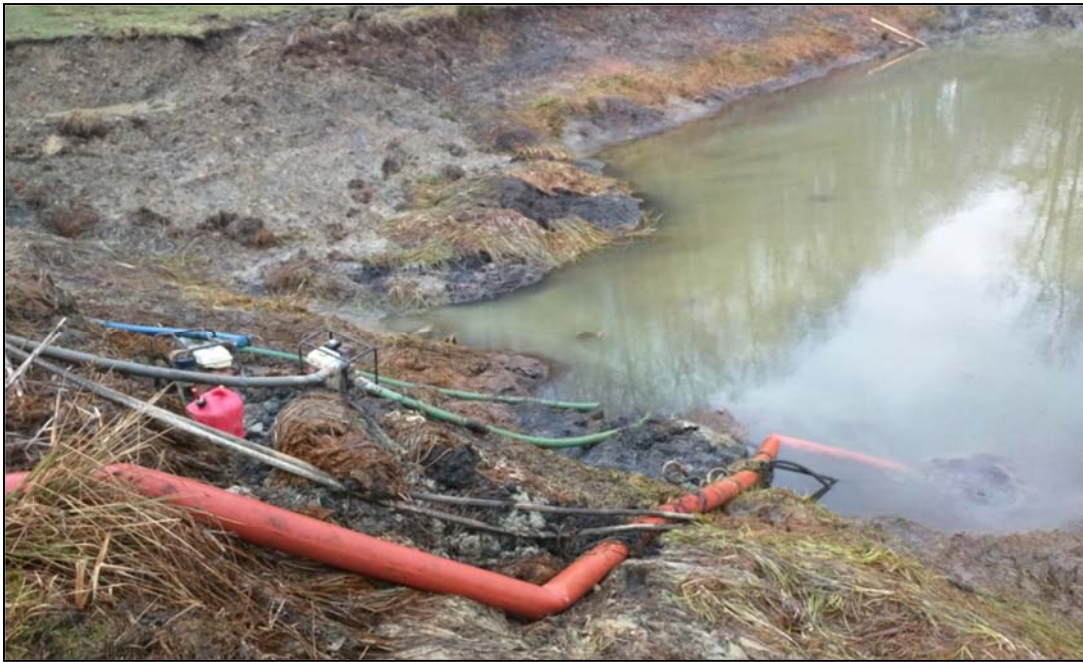
The vertical flow ponds at the Ferris Passive Treatment System Complex were pumped down to gain access to the treatment media.

Initially, flow from the forebay through VK1 was not present, causing raw water from the forebay berm to bypass both vertical flow ponds directly to the treatment wetland. VK1 maintained a high water level but did not flow to VK2, which indicated the treatment media and/or the underdrain was plugged. Several attempts were made to unplug the pipe and media. A flush pipe was located within the forebay and found to be closed or blocked on the inlet side. An emergency overflow pipe was located and cleared within VK1 using a power snake attachment, which dropped the water level in the pond approximately 2 feet. The treatment media was backflushed using a 3" pump for approximately 20 minutes during three separate attempts to gain a flow path within the media to the underdrain. This netted a minimal increase in flow to the underdrain pipe.

After further backflushing attempts proved unhelpful in reestablishing flow through the system, it was decided that exposing the underdrain pipes and examining the quality of the treatment media would help to determine the next course of action. A temporary berm to divert flow from the forebay was installed and VK1 was drained over the course of a few days to accomplish this. Once VK1 drained, an excavator was used to examine the quality of the treatment media within the pond. The media was separated into two layers. The top layer was highly degraded with no structure, and the lower layer was highly compacted and minimally permeable. After determining it had little viability in continuing to provide water treatment, a significant amount of the top layer of media was removed from the pond using a 6" shredder pump. The lower layer of media was then removed to examine the underdrain and surrounding stone. This revealed a cemented together layer of stone with 4" perforated underdrain pipe that still had no flow exiting the flush pipe. A redesign of VK1 was determined to be necessary to regain treatment within the component.

A spillway was installed between VK1 and VK2 to allow water treatment in VK2 without flowing through the VK1 media. Stop logs regulating water level within VK2 were removed to help determine the permeability of the stone within the pond. A layer of sediment approximately 6-8" thick was discovered on top of the treatment media stone. Although VK2 drained, it would benefit from stirring the media and removing sediment using a 6" shredder pump to rejuvenate the stone. This was performed after work was completed within VK1. Hopefully, in the coming year, additional funding can be acquired to make the necessary changes to this treatment system.
