RELICS UPON THE LAND

ACID MINE DRAINAGE

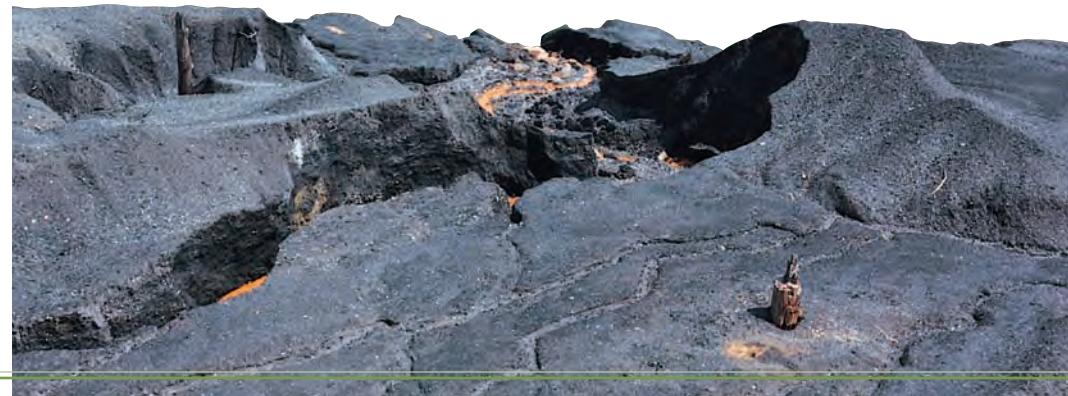
*Severely eroded coal refuse piles
(Photo courtesy of US Dept. of the Interior, Office of Surface Mining Reclamation and Enforcement)*

Coal refuse piles are mounds of soil, rock, coal and coal-like materials located where coal is prepared for market, often near the mine entrance. These materials are not marketable and need to be removed from the rest of the coal after leaving the mine. This is accomplished by separating the coal from the waste. Historically, young boys did this by hand. Since these materials come from deep within the mine they often contain the mineral pyrite and are a source of AMD. There are approximately 2.6 billion cubic yards (approximately 62 million tractor-trailer loads) of coal **refuse piles**

dotting the landscape of Pennsylvania. A convoy of trucks twice encircling the globe would be needed to remove Pennsylvania's coal refuse piles. Many of these piles are in or near streams, thus contributing greatly to the state's coal mine drainage problem.

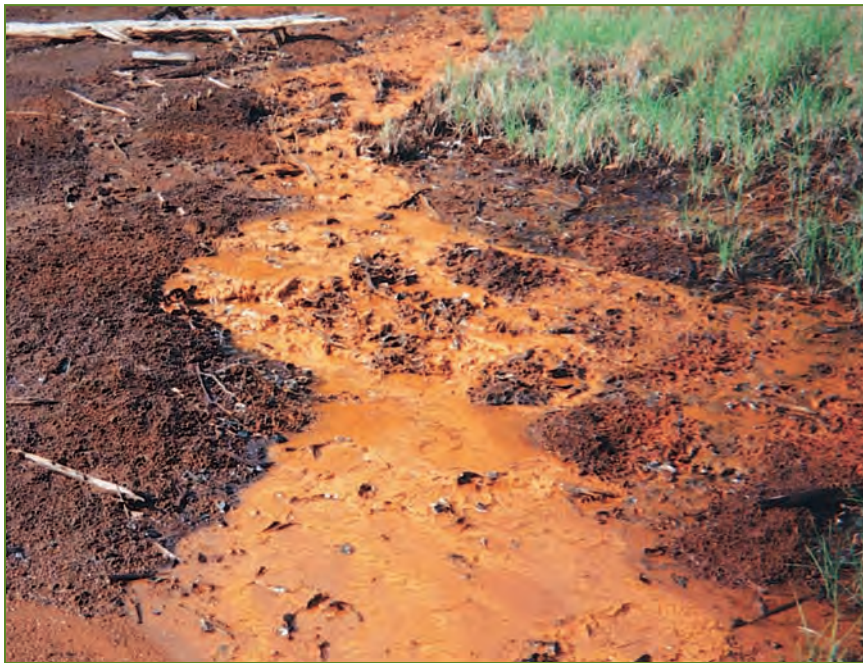
Abandoned mine drainage (Photo courtesy of Stream Restoration Incorporated)

sulfur that is often found in or near coal seams. Oxygen and water react with the pyrite creating a mild form of **sulfuric acid**, with similar acidity to vinegar. This acidic solution is capable of dissolving many of the minerals and metals it may come in contact with. The resulting mine drainage can contain not only iron but also other metals such as aluminum and manganese. This combination of acid and metals can have a disastrous effect on a stream habitat. Acid mine drainage is often easily recognized by reddish-orange staining of rocks, discolored

water, and the absence of vegetation; however, in many cases the water can appear clear and clean.

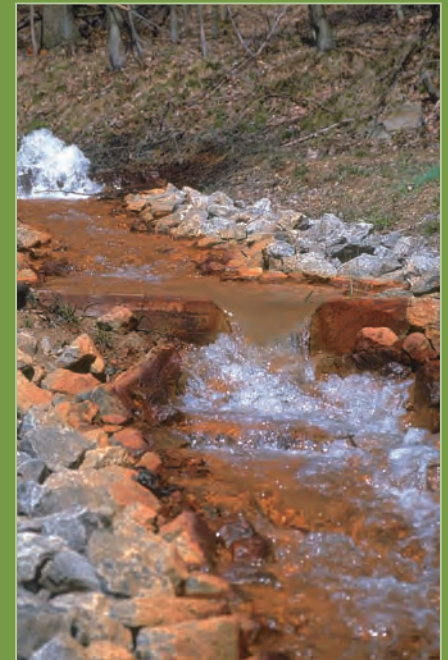
Acid drainage continuously flows from this abandoned underground mine in northern Butler County. (Photo courtesy of Stream Restoration Incorporated)

Miners in early underground mines were faced with a problem to which most of us can relate. Dig a hole and chances are it will fill with water. Having a mine fill with water was both uncomfortable and dangerous to the early coal miner. To solve this dilemma miners used the cheap and plentiful force of gravity. Rather than dig down to the coal seam, mine entrances were often located at the lowest point of the coal bed where it was exposed at the surface. This allowed water to drain out of the mine rather than collect where the miners must work. This inexpensive and efficient method of draining the mine was so effective it continues to work years after the mine has closed. Many abandoned mines have miles of underground "tunnels" that act as reservoirs to brew AMD. The result is

a steady stream of damaging mine drainage flowing from hundreds of abandoned drift mines throughout Pennsylvania. Improved mining technology, such as pumps and ventilation systems, make this method of keeping the mine safe and relatively dry obsolete. Today, every part of a mine must be located below the level of the entry, thus inhibiting the discharge of mine drainage from the entry.

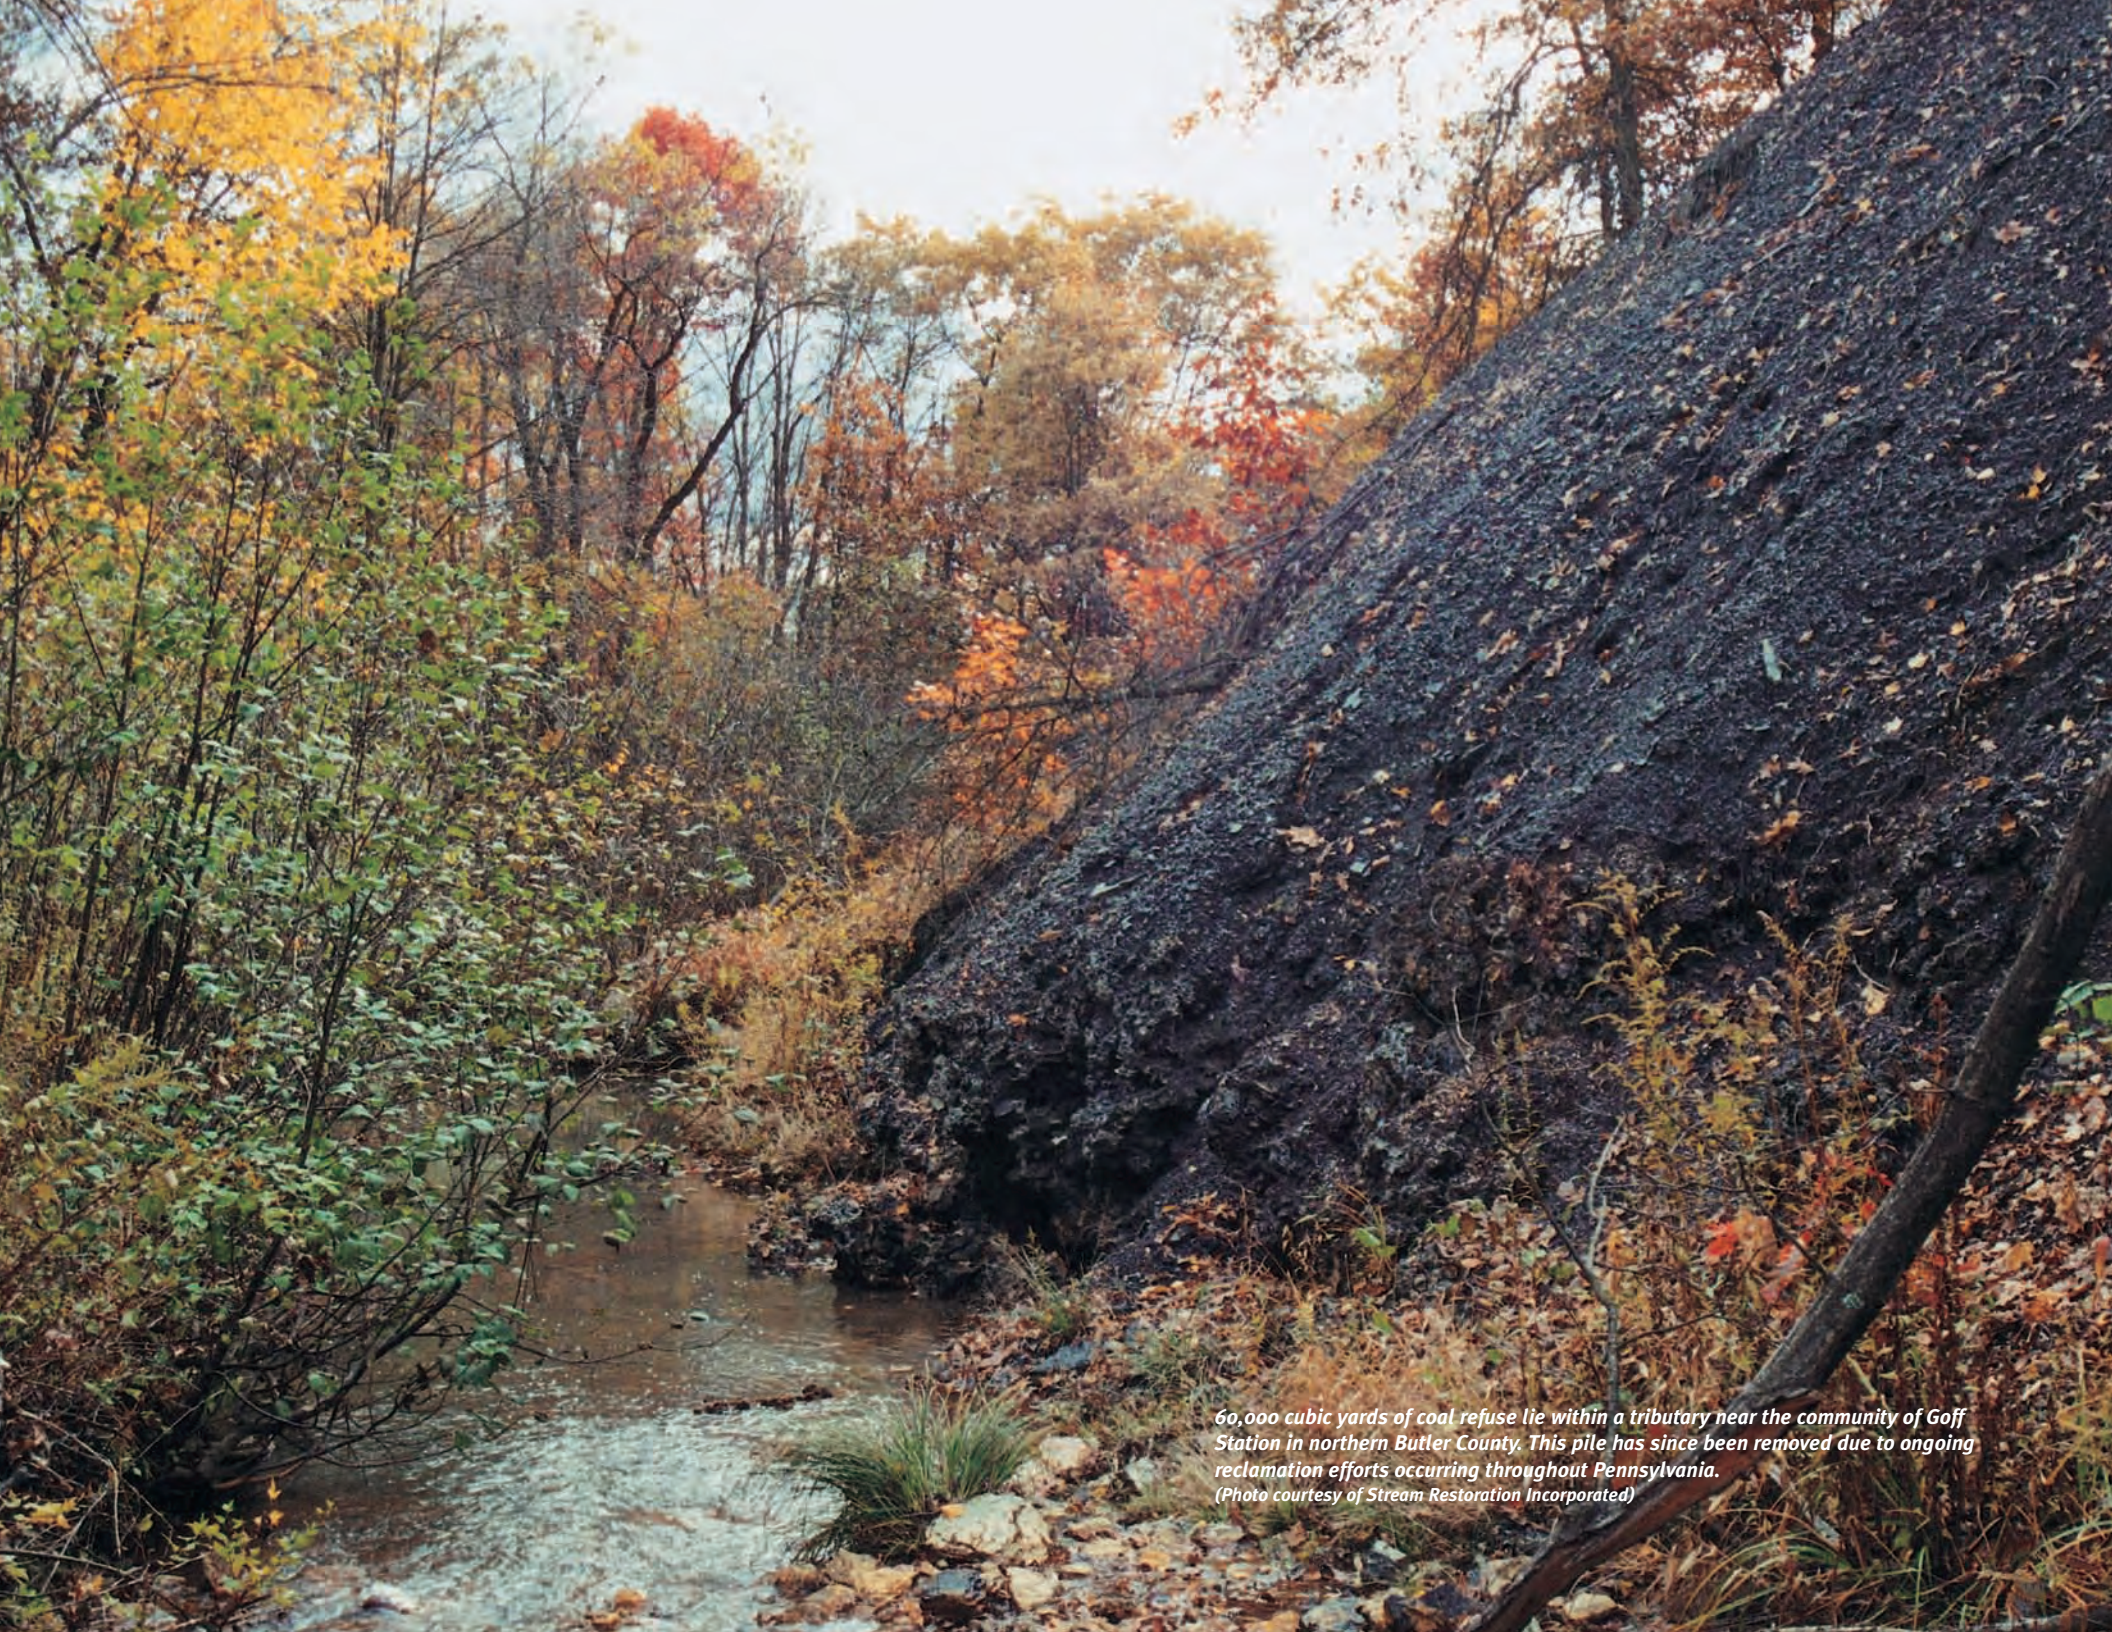
*60,000 cubic yards of coal refuse lie within a tributary near the community of Goff Station in northern Butler County. This pile has since been removed due to ongoing reclamation efforts occurring throughout Pennsylvania.
(Photo courtesy of Stream Restoration Incorporated)*

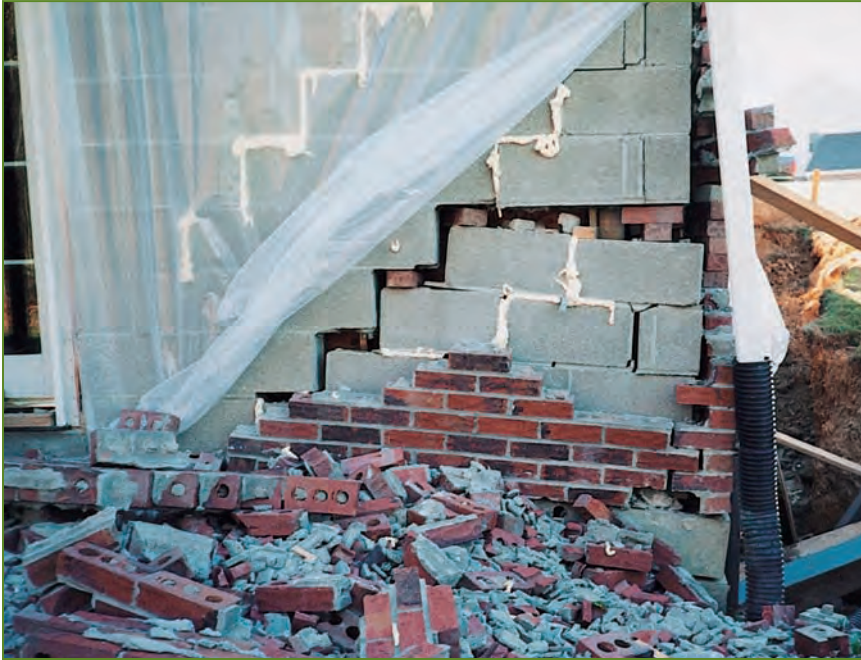
Subsidence depressions may cause extensive property damage.
(Photo courtesy of US Dept. of the Interior, Office of Surface Mining Reclamation and Enforcement)

Subsidence depressions, which look like sink holes, occur when the surface of the ground sinks due to significant excavation beneath the surface. Due to erosion over time, the roof of an underground mine may no longer be able to support the weight of the overlying rocks and will collapse. Areas susceptible to subsidence depressions may look stable for many years. Structures may be built in these areas, later to be severely damaged when the ground sinks. Subsidence depressions tend to collect water. This water often drains into the abandoned mine, contributing to the formation of acid mine drainage. These mine-related depressions can be dangerous. Vegetation often conceals the depression increasing the chance of an unexpected fall and injury.

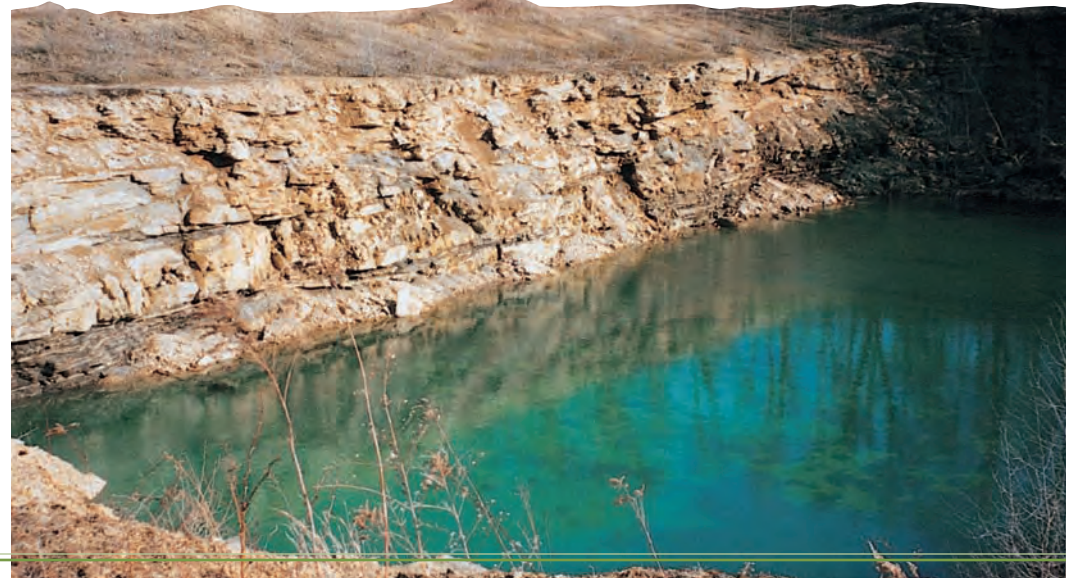
A relatively small, yet dangerous, highwall and open pit, abandoned after a surface mining operation
(Photo courtesy of DEP, Knox District Mining Office)

During surface mining, a hillside is often removed to reveal the underlying coal. This vertical open cut is similar to cuts frequently seen along roadsides where a hillside has been removed to make room for the road. If the mine ceases to operate, the cut that remains is called the **final face** of the mine and is often referred to as a **highwall**. Highwalls are

extremely steep and can be dangerously high. Erosion, slumping and rockslides are commonly associated with highwalls. Today, surface mine operators are required to restore the surface of the earth to its original shape, called approximate original contour. Hillsides must be repaired so that no highwall remains.

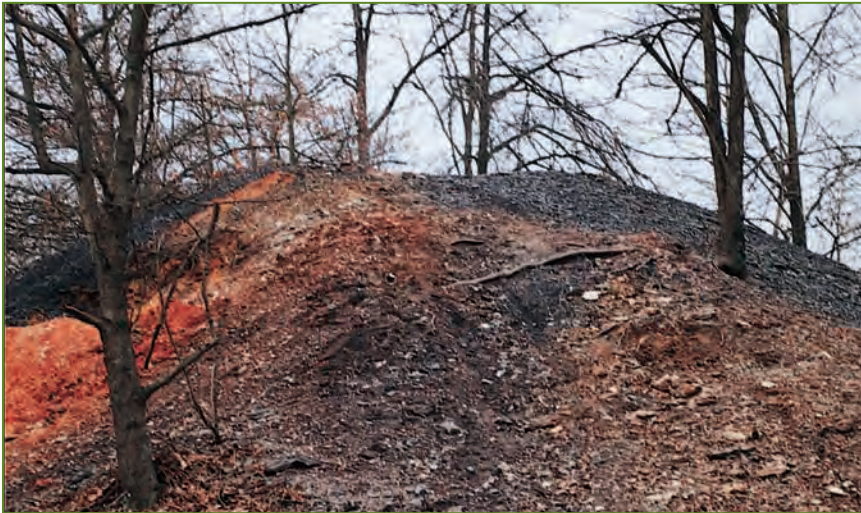
Very little vegetation will grow on spoil piles, encouraging erosion and the weathering of acid bearing materials. (Photo courtesy of Jennings Environmental Education Center)

Overburden removed during surface mine operations was placed in a pile near the newly exposed **pit**. These piles can become quite expansive depending on the size of the operation. These huge piles of earth contain minerals, such as pyrite, that can produce acid mine drainage when exposed to oxygen and water. Often the materials found closest to the coal seam contain these acid producing minerals. Similar to digging a hole with a shovel, the material to last be removed from the hole is placed on top of the pile and in direct contact with the air and water. Abandoned spoil piles produce a significant amount of acid mine drainage. In addition, vegetation rarely grows on these piles so wind and

rain easily erode them. This erosion causes sedimentation and increased turbidity in streams, which can choke fish and hurt vegetation.
